Map 5.5-1
Portland Harbor RI/FS
Remedial Investigation Report
Transition Zone Water Chemistry
Total DDX ($\mu\text{g/L}$)
River Mile 6.8 to 7.8

Portland Harbor RI/FS
Remedial Investigation Report
Transition Zone Water Chemistry
Total PAHs ($\mu\text{g/L}$)
River Mile 04 to 05

**Portland Harbor RI/FS
Remedial Investigation Report
Transition Zone Water Chemistry
Total PAHs (μ g/L)
River Mile 05 to 06**

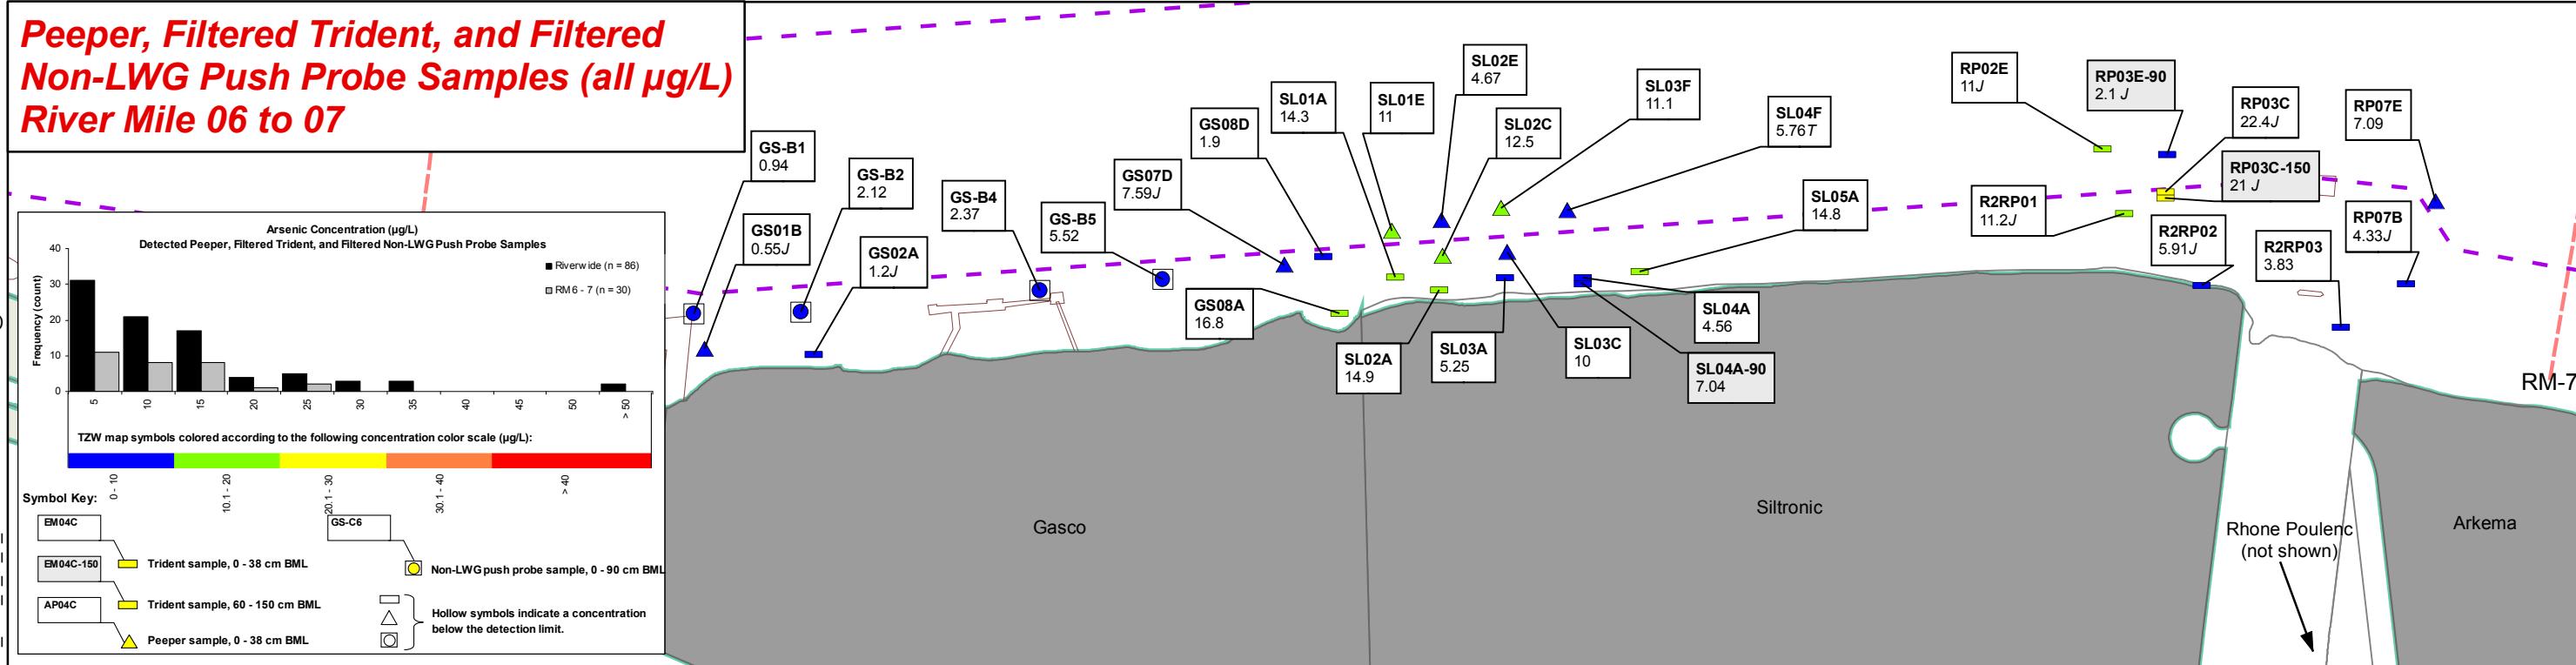
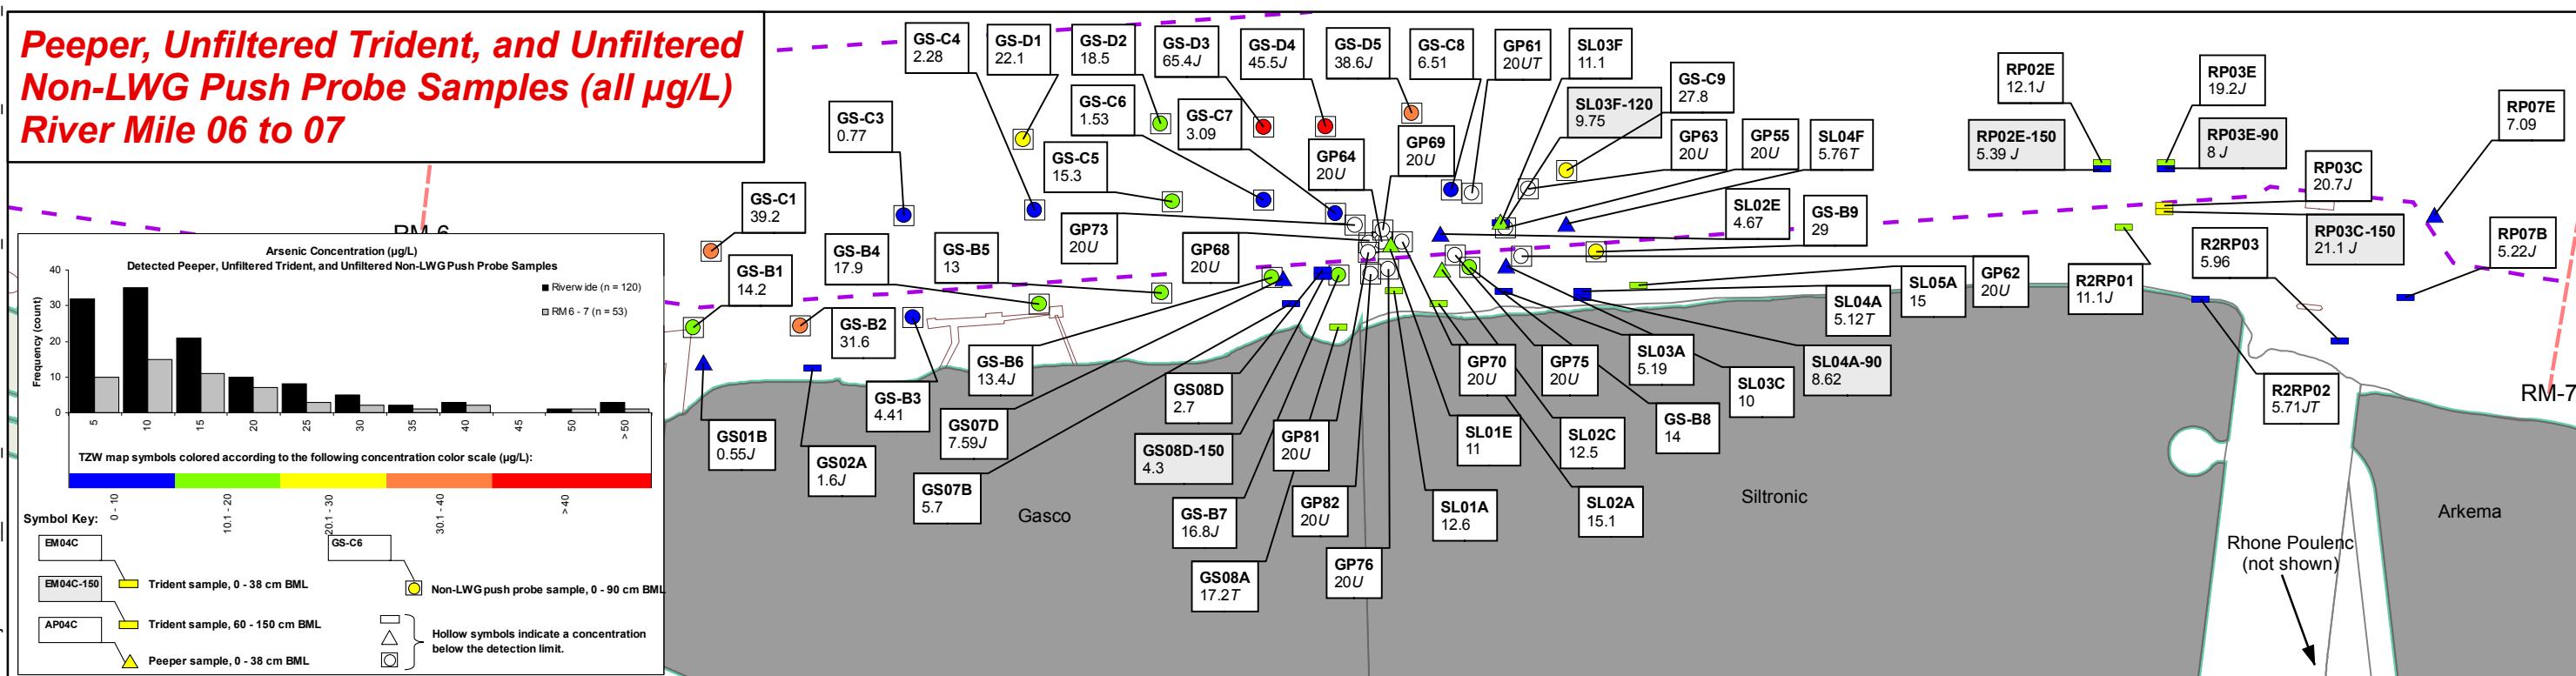
Map 5.5-3c

Portland Harbor RI/FS
 Remedial Investigation Report
 Transition Zone Water Chemistry
 Arsenic (µg/L)
 River Mile 06 to 07

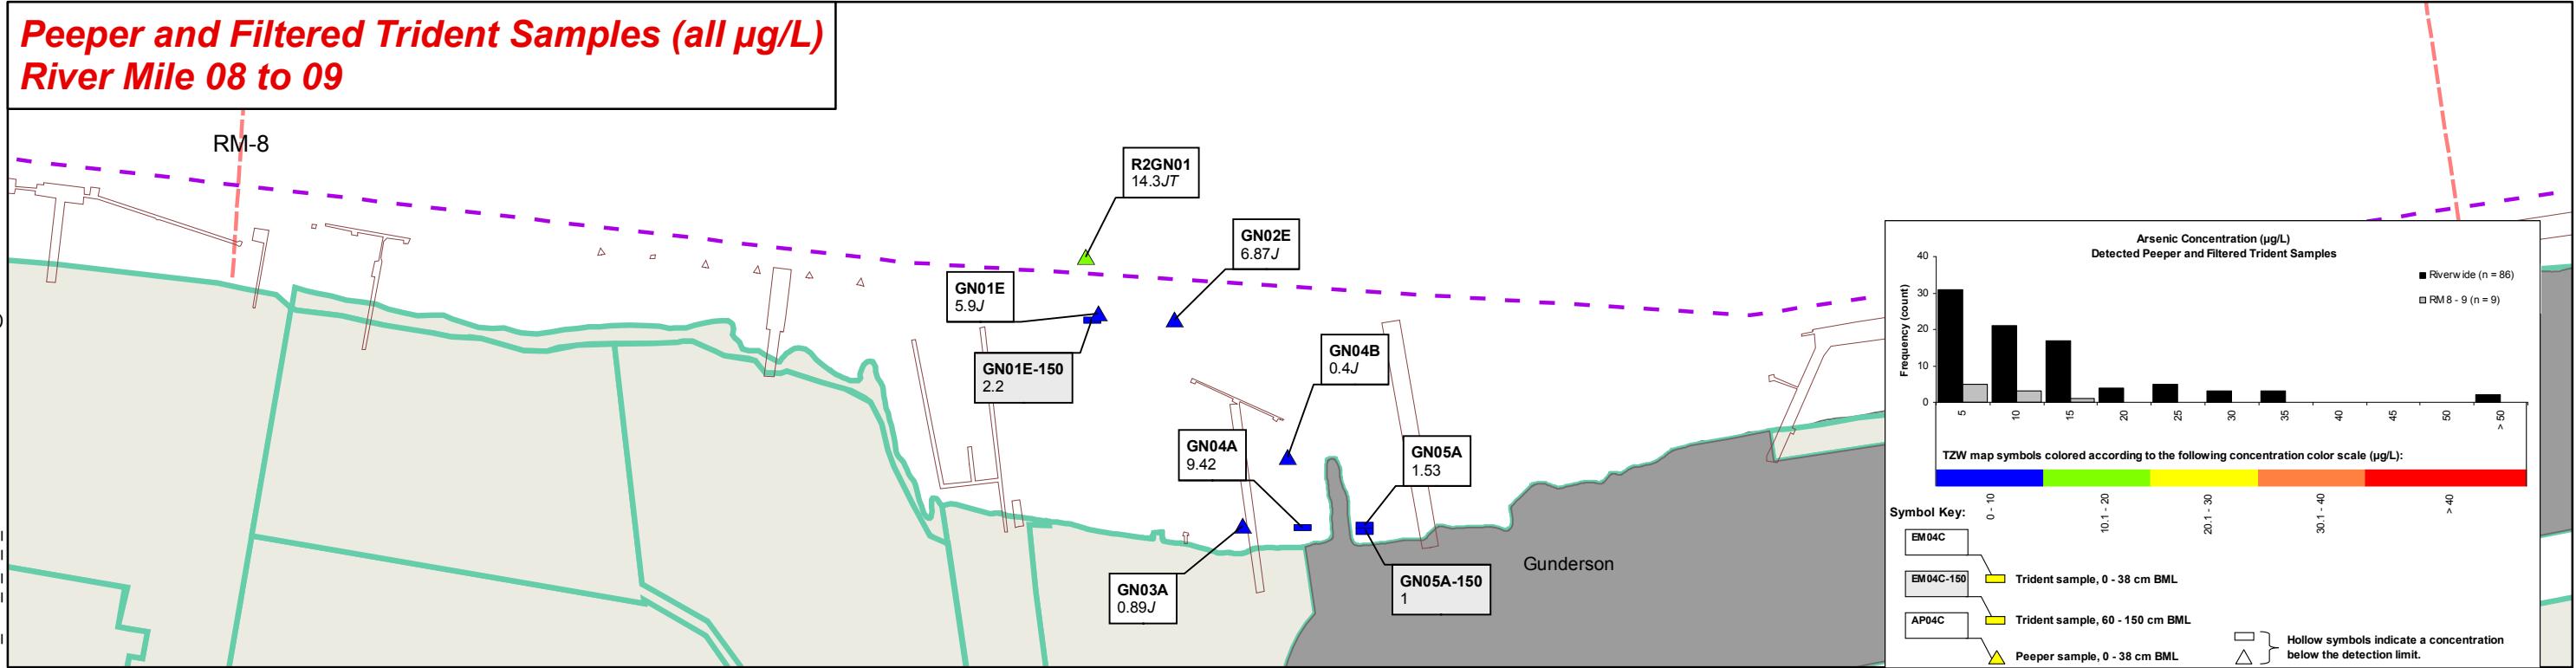
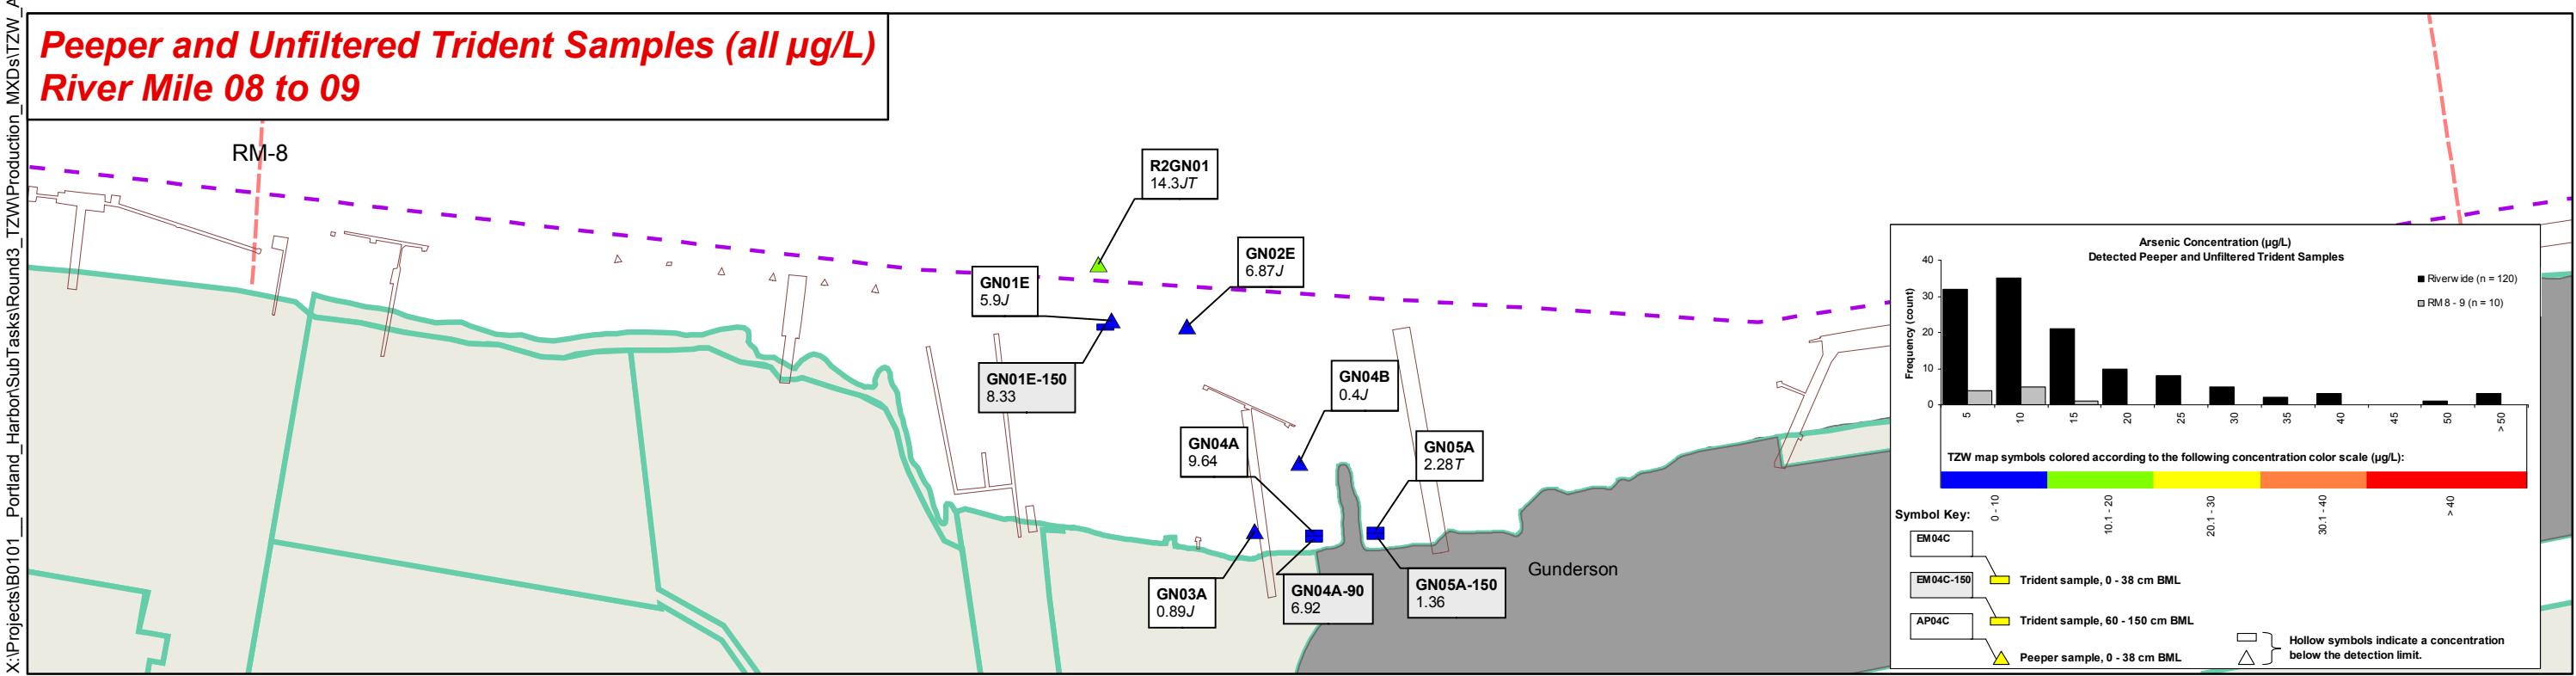
Map 5.5-3e

Portland Harbor RI/FS
 Remedial Investigation Report
 Transition Zone Water Chemistry
 Arsenic (µg/L)
 River Mile 08 to 09

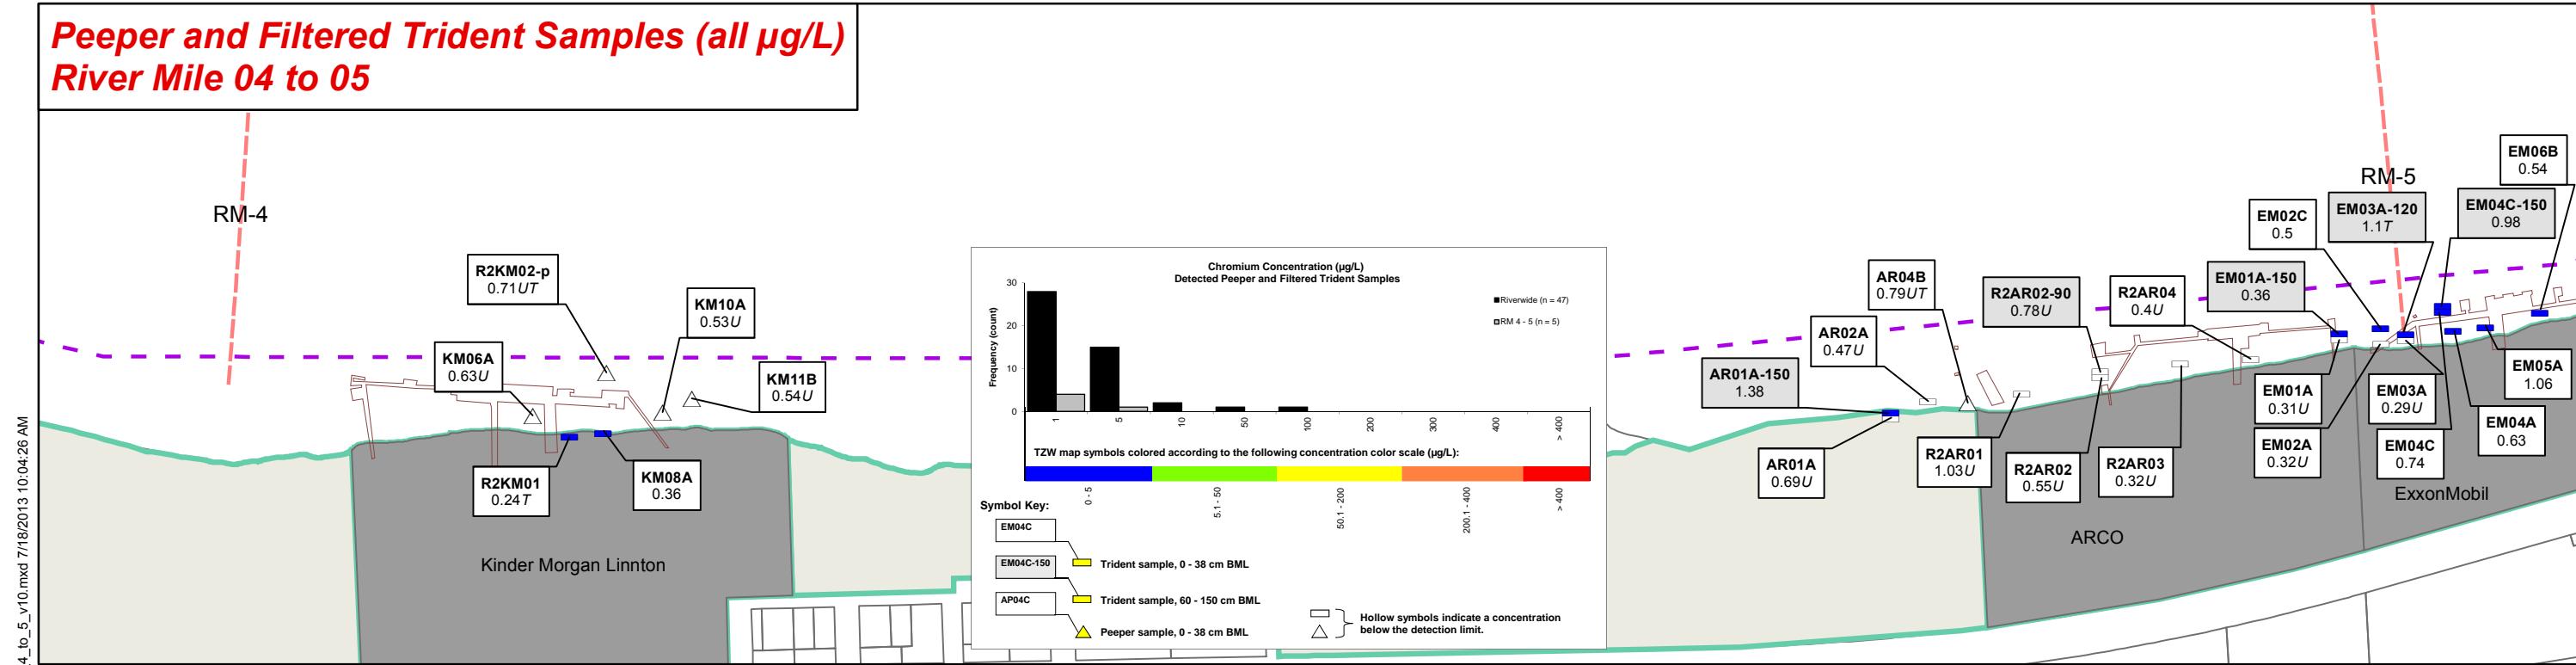
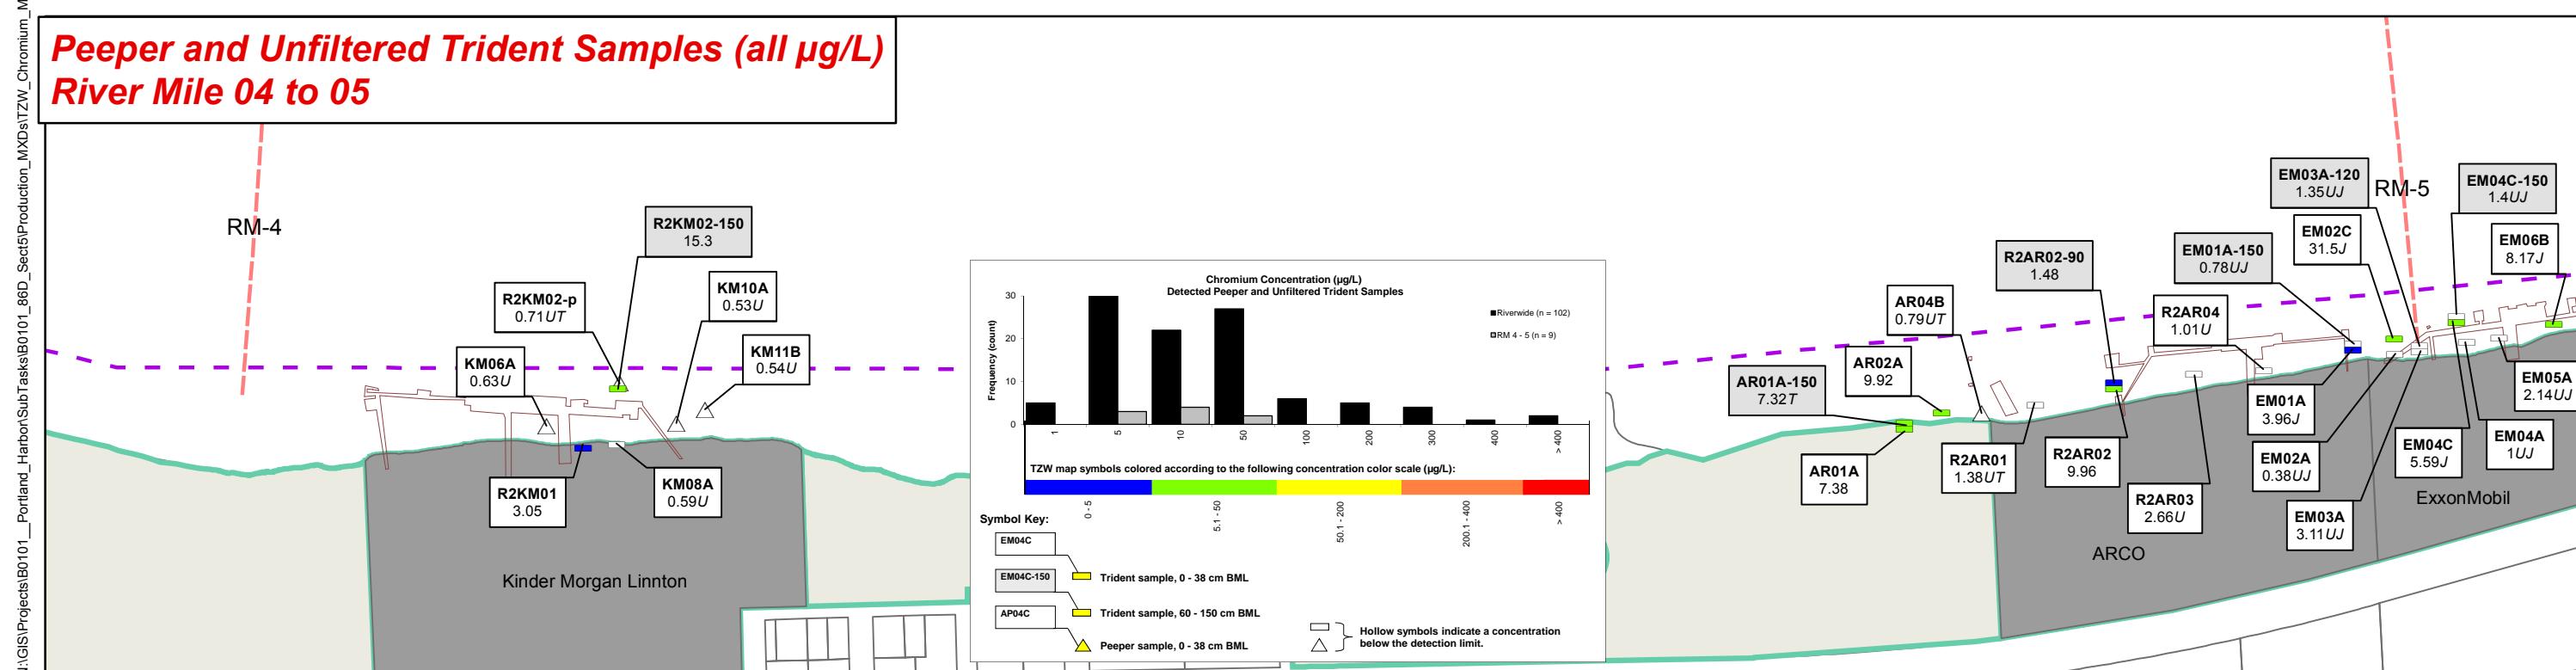
Map 5.5-4a

**Pepper and Filtered Trident Samples (all $\mu\text{g/L}$)
River Mile 04 to 05**

**Pepper and Unfiltered Trident Samples (all $\mu\text{g/L}$)
River Mile 04 to 05**

Portland Harbor RI/FS
Remedial Investigation Report
Transition Zone Water Chemistry
Chromium ($\mu\text{g/L}$)
River Mile 04 to 05

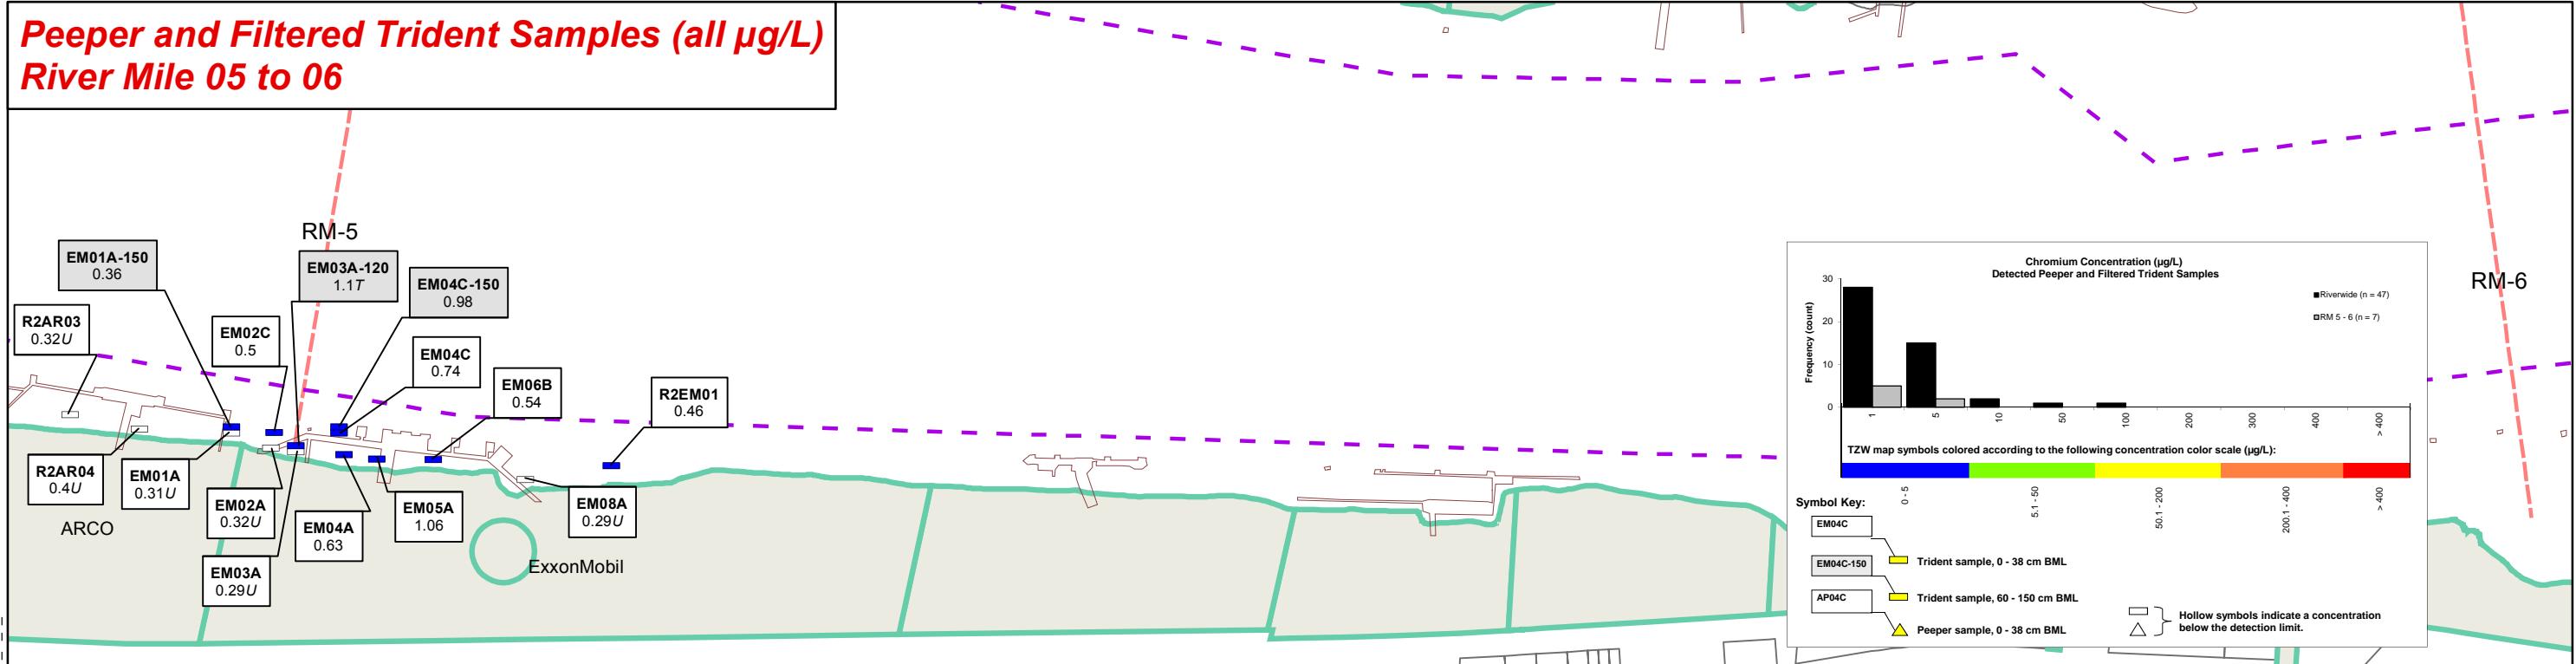
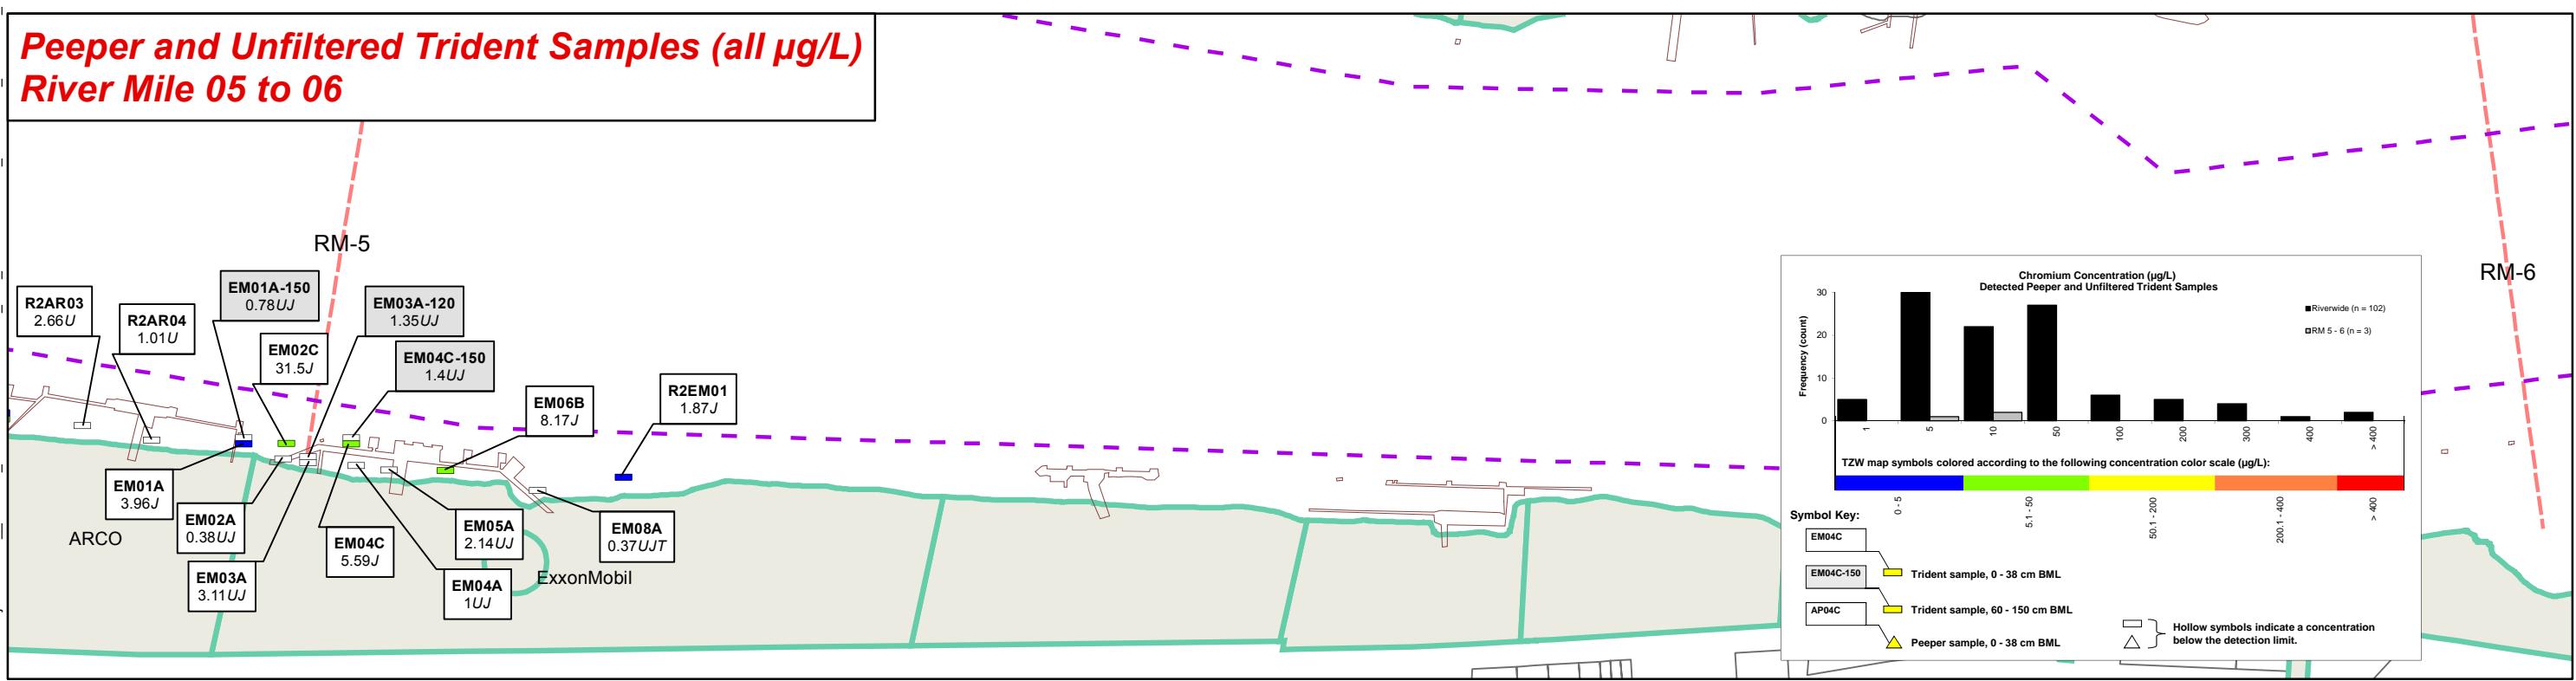
Map 5.5-4b

Portland Harbor RI/FS
Remedial Investigation Report
Transition Zone Water Chemistry
Chromium ($\mu\text{g/L}$)
River Mile 05 to 06

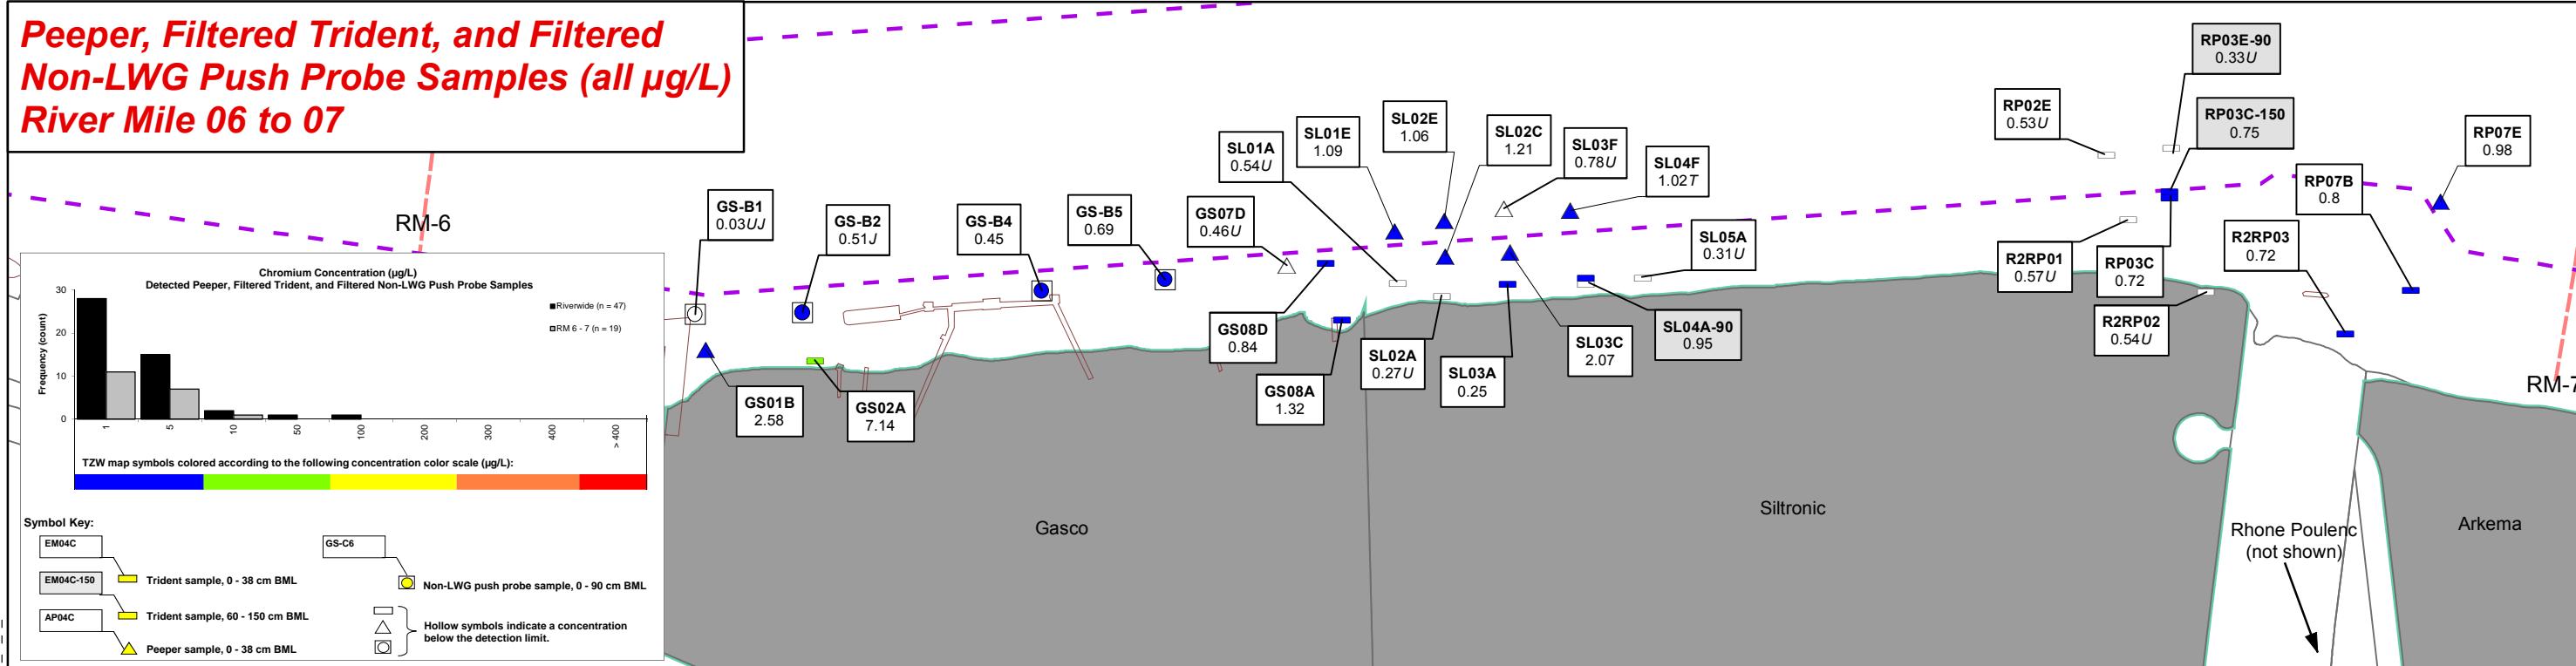
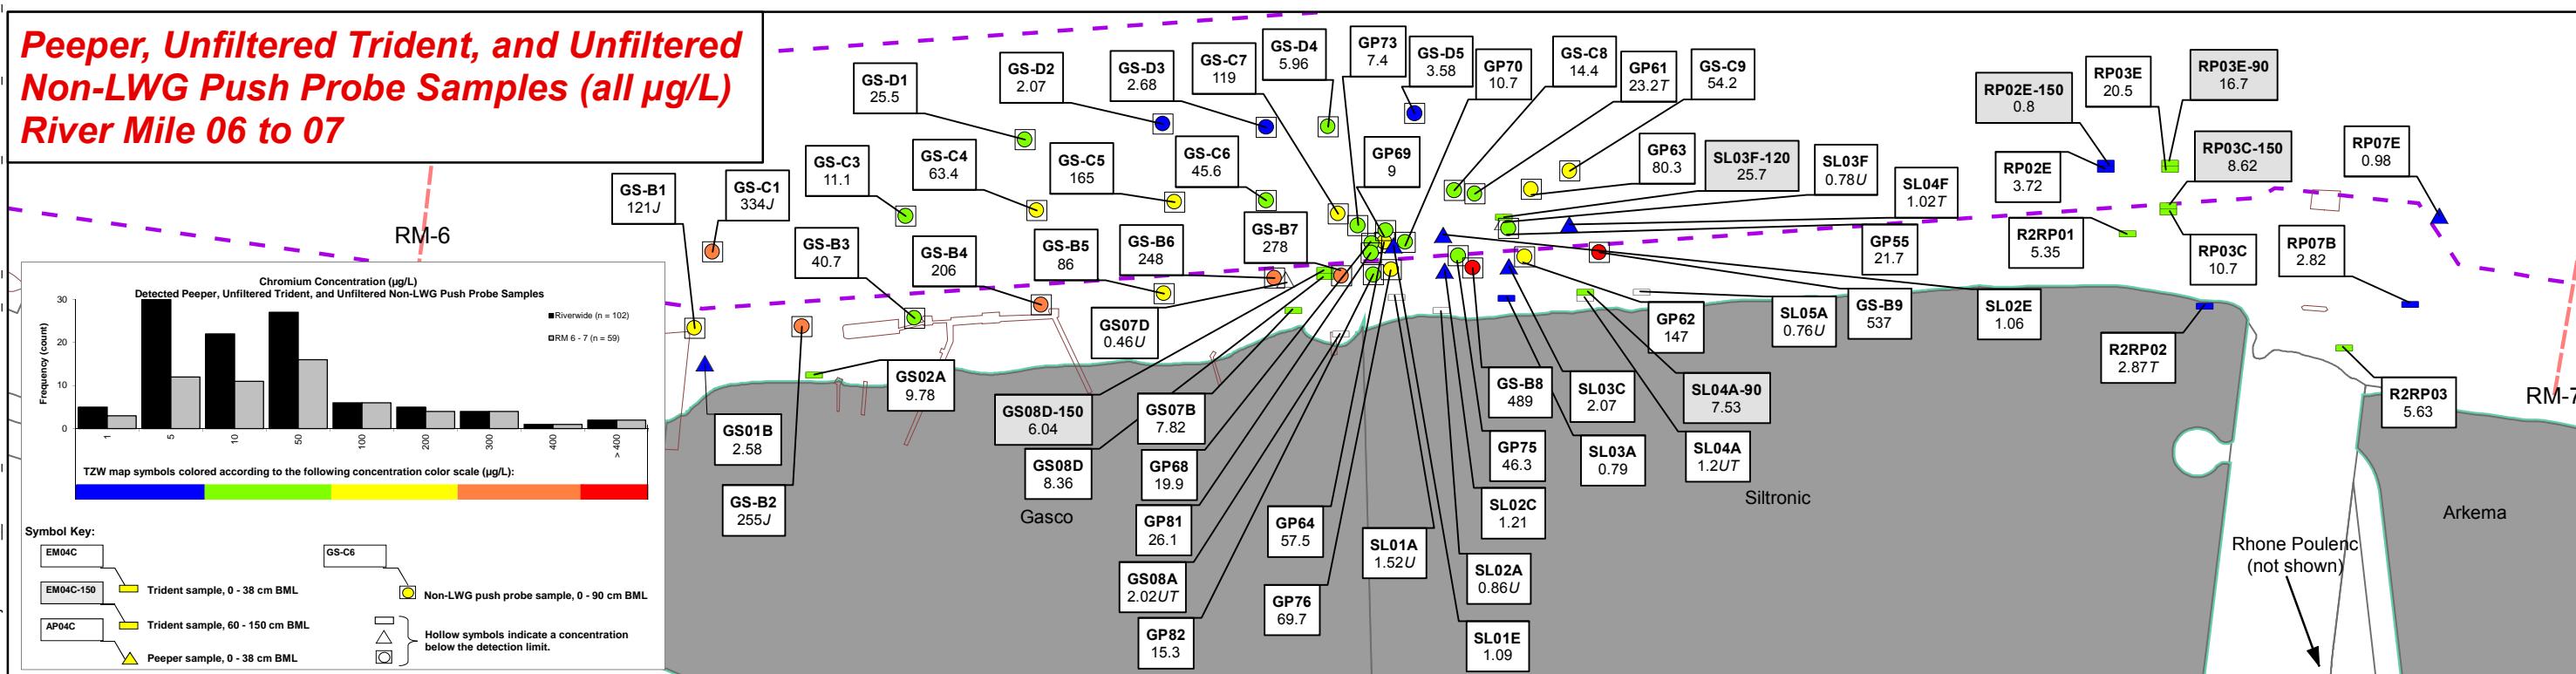
Map 5.5-4c

Portland Harbor RI/FS
Remedial Investigation Report
Transition Zone Water Chemistry
Chromium (µg/L)
River Mile 06 to 07

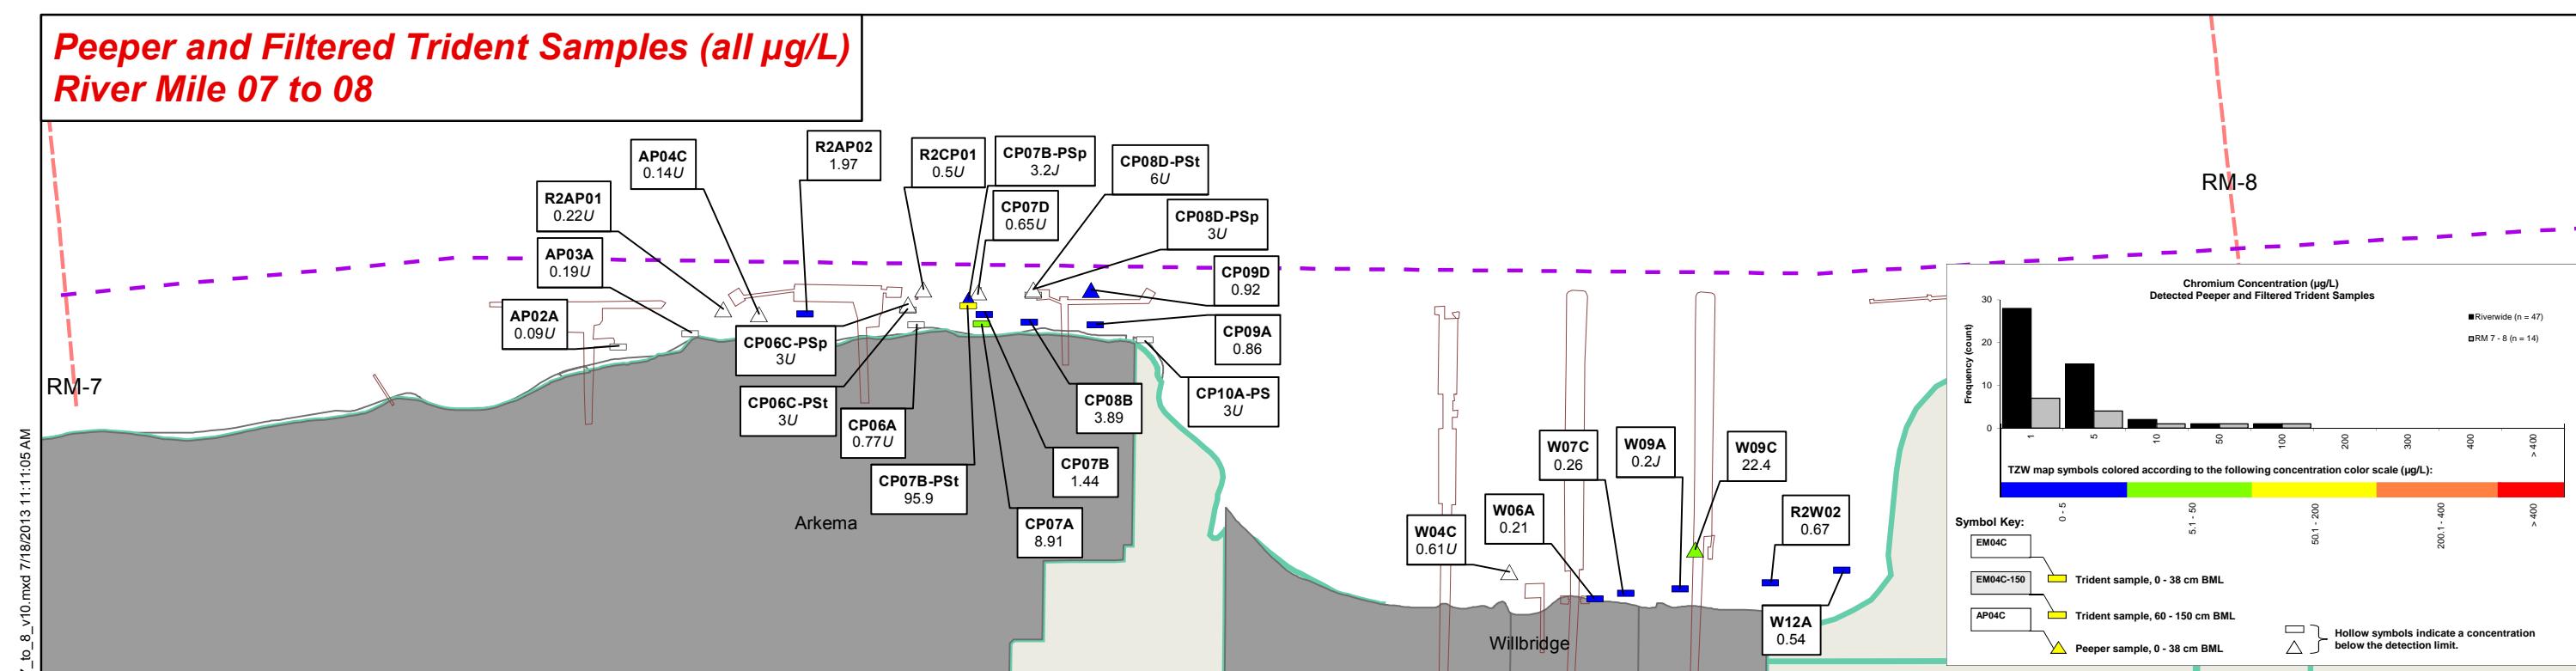
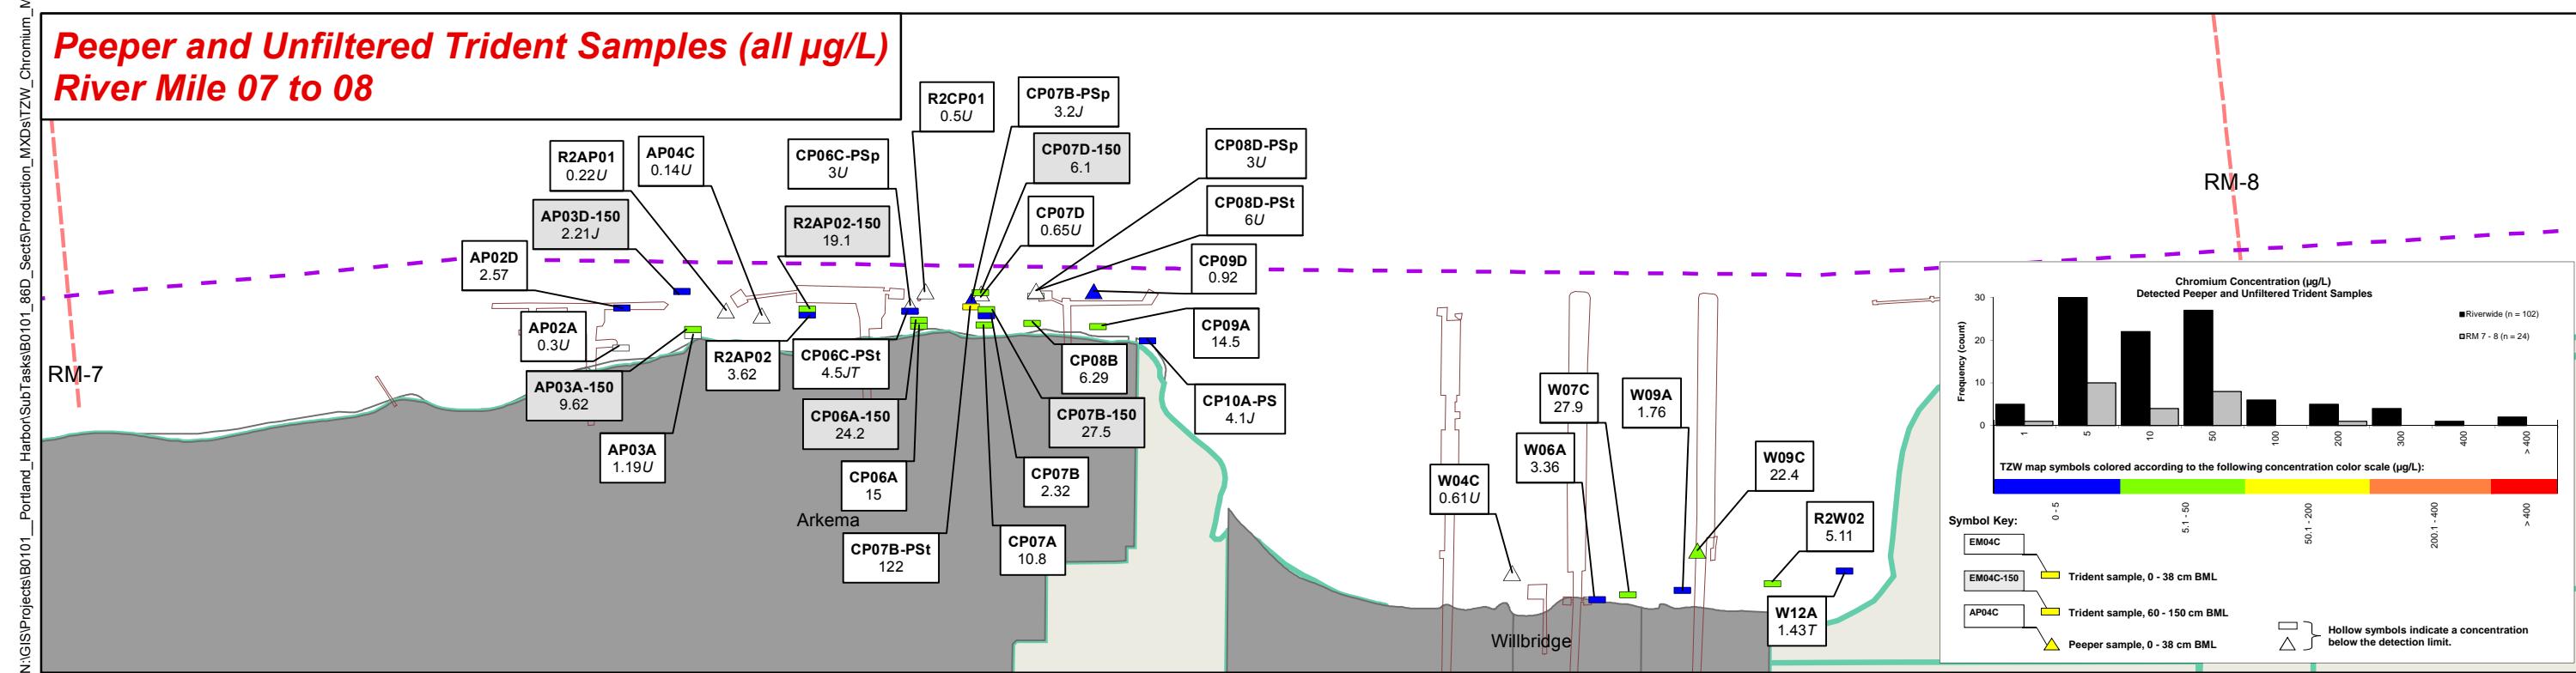
Map 5.5-4d
Portland Harbor RI/FS
Remedial Investigation Report
Transition Zone Water Chemistry
Chromium ($\mu\text{g/L}$)
River Mile 07 to 08

**Peeper and Filtered Trident Samples (all $\mu\text{g/L}$)
River Mile 07 to 08**

**Peeper and Unfiltered Trident Samples (all $\mu\text{g/L}$)
River Mile 07 to 08**
